White River Integrated Water Initiative

Reach Report Middle White River

Spring 2022

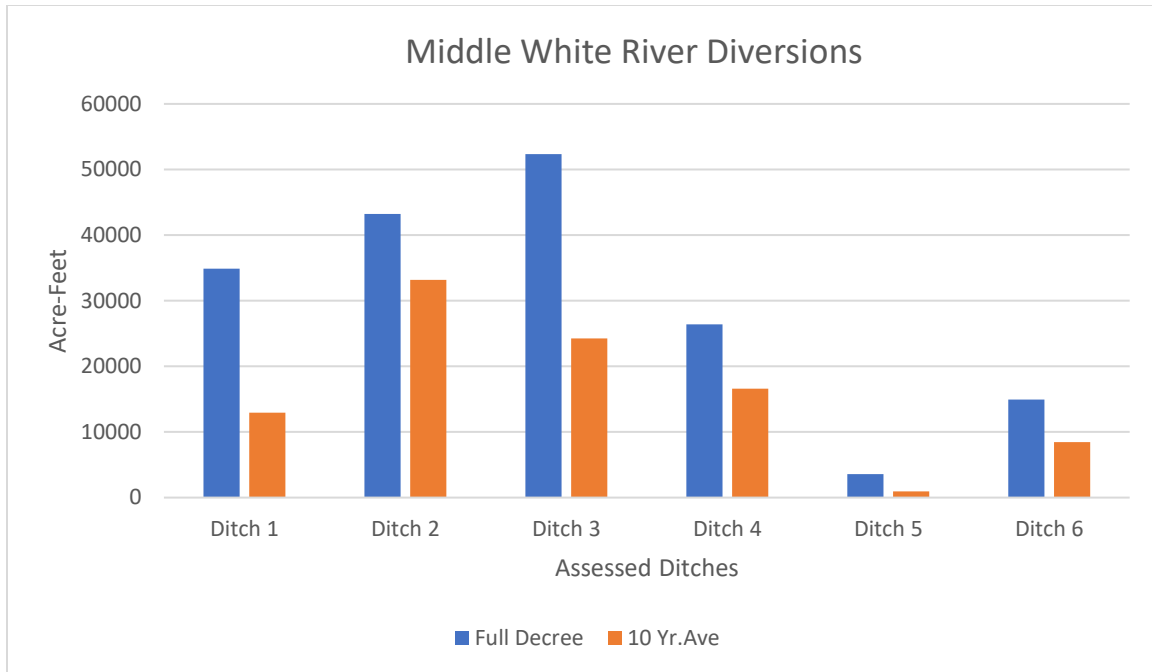
Source: CDSS Structure Report

The difference between the full decree and actual amount of water diverted in several ditches is often due to the lack of water available to divert throughout the entire irrigation season and/or voluntary measures to maintain stream flow.
