# White River Integrated Water Initiative

## Reach Report Upper White River

Spring 2022

There are three main components in Phase II of the White River Integrated Water Initiative: Public Outreach/Community Engagement, Diversion Assessments, and Riparian Assessments.

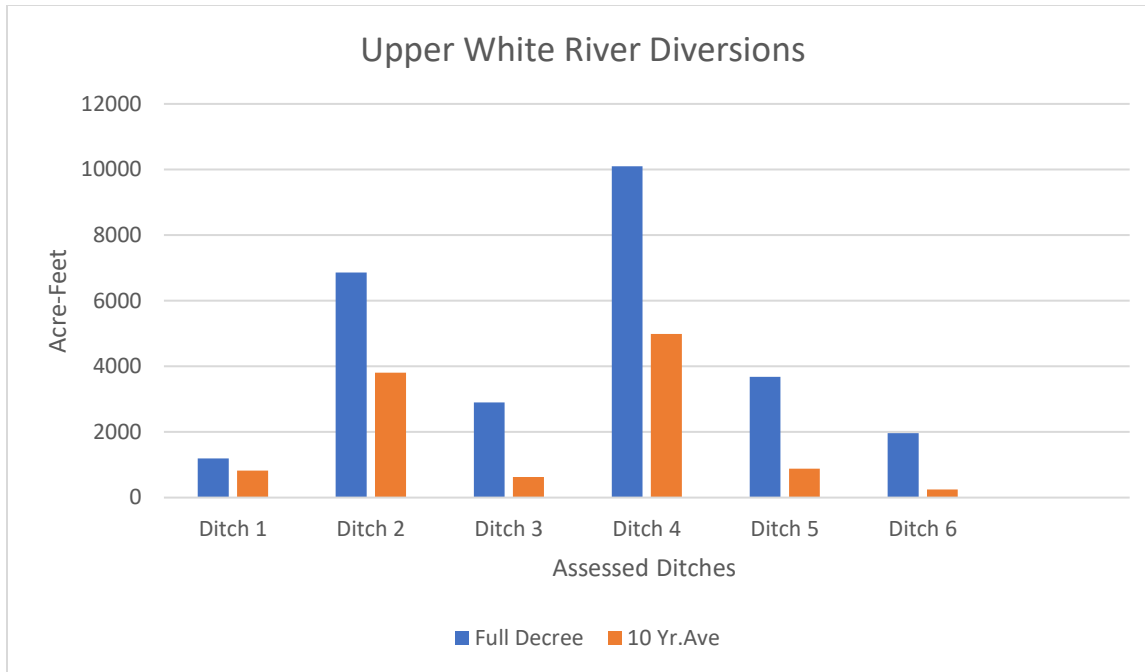
Source: CDSS Structure Report

**The difference between the full decree and actual amount of water diverted in several ditches is often due to the lack of water available to divert throughout the entire irrigation season and/or voluntary measures to maintain stream flow.**
